NATIONAL BUREAU OF STANDARDS REPORT

8352

PERFORMANCE OF ROOFINGS ON GUAM, M.I. AND OKINAWA, R.I.

20 May 1964

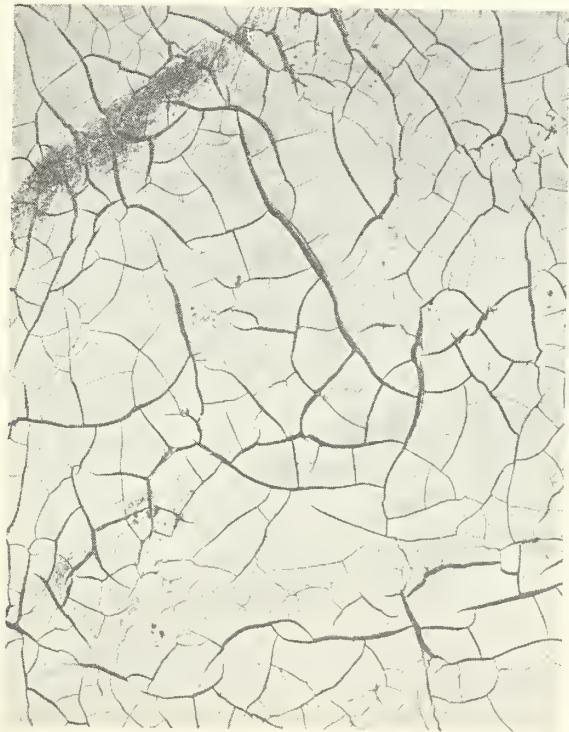
FIGURE 1. WEATHERING PATTERN, ASPHALT-SURFACED ROOF ON GUAM OBSERVED IN 1954.

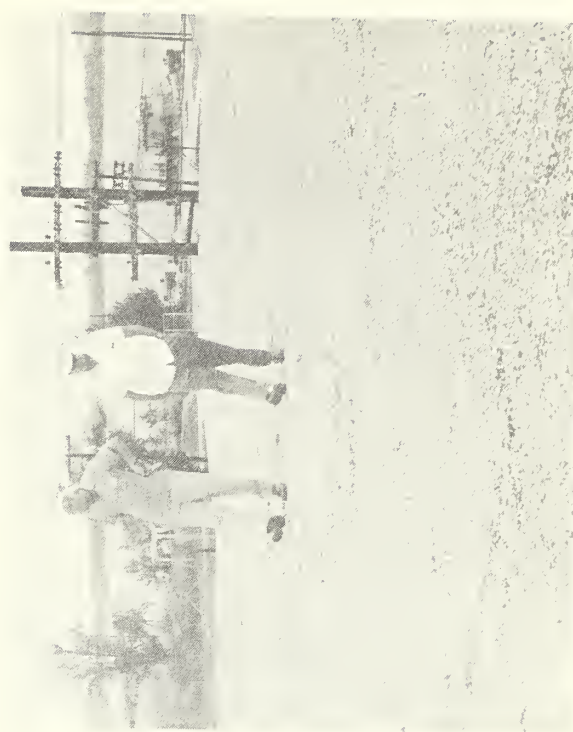
FIGURE 4. CORAL-SURFACED BUILT-UP ROOF, OROTE POWER PLANT, GUAM. AGE: 10 YEARS.

surfaced built-up roofs on the Orote Power Plant, the U. S. Naval Hospital, and the Fleet Laundry which have served very satisfactorily after 10, 8, and 7 years, respectively. However, it was observed that each of these roofs required immediate preventive maintenance as exemplified by the area shown in Figure 7. Figure 8 shows the gradation of the manufactured coral aggregate and the excellent coverage obtained with this material on the hospital roof. Similar service was obtained from surfaced built-up roofs observed on the Commissary Building and the CE Shops Building at Anderson Air Force Base.

The good performance of these roofings was attributed to the use of mineral surfacing, to the elimination of insulation from the top of the deck, and to the use of a softer asphalt.

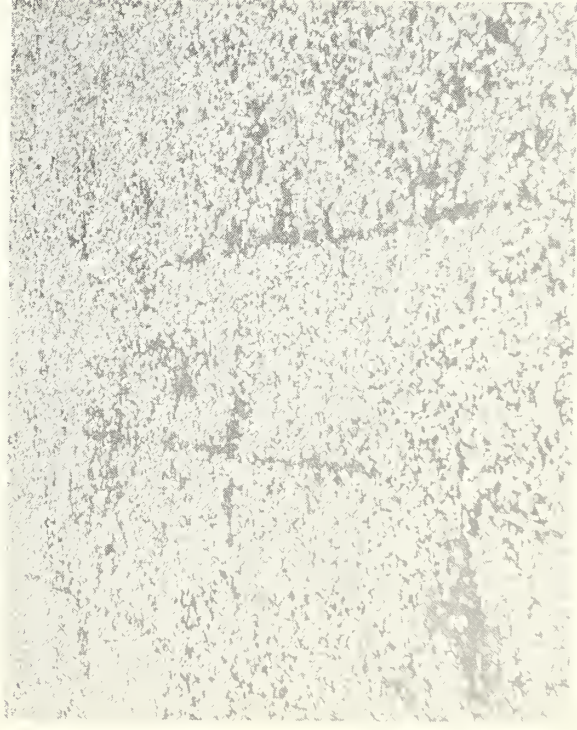
FIGURE 7. EXPOSED FELTS WHICH INDICATE
NEED FOR PREVENTIVE MAINTENANCE. OROTE
POWER PLANT.

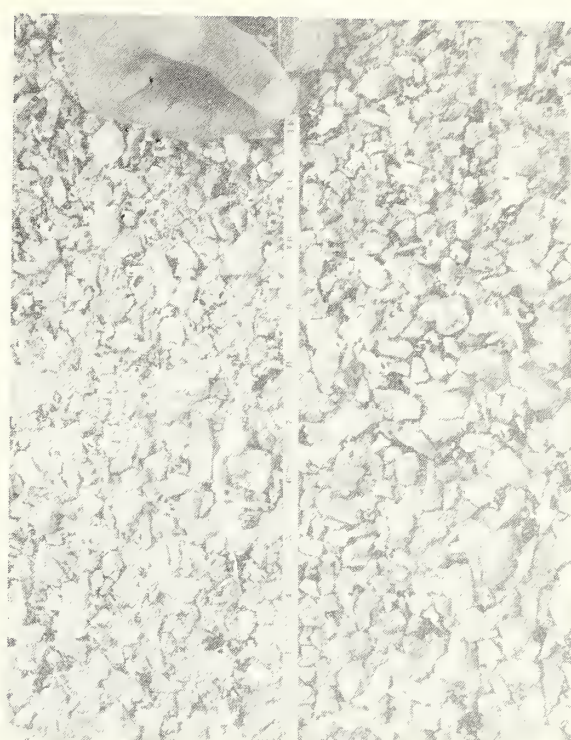
FIGURE 8. EXCELLENT COVERAGE PROVIDED
BY MANUFACTURED CORAL AGGREGATE.

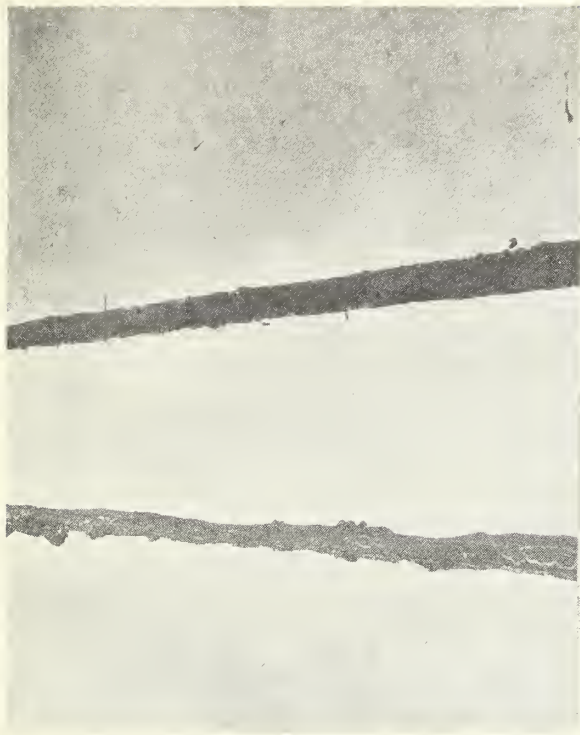
FIGURE 10. CLOSE-UP OF JOINT SHOWN IN
FIGURE 9.

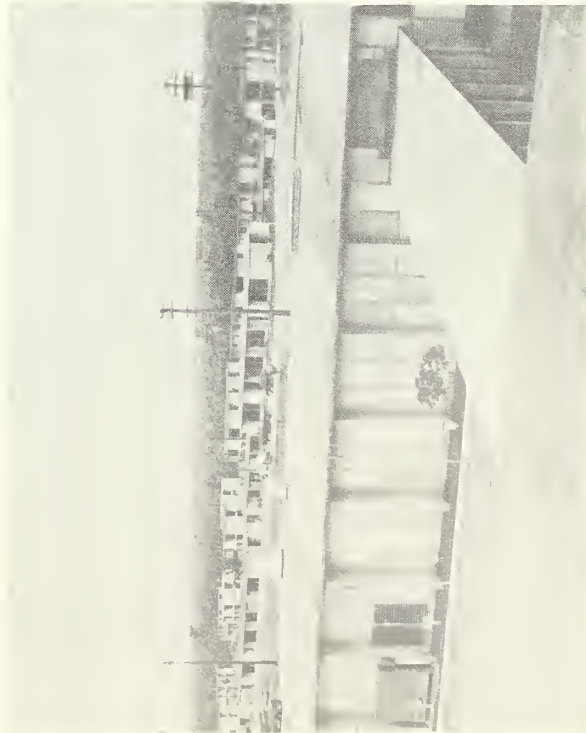
The poured-in-place slabs have two advantages over their pre-cast counterparts in that they have fewer joints to treat and are of greater thickness. Consequently, they have performed very satisfactorily as exposed decks for at least 10 years on Guam Island. Observations of typical slabs indicated no leakage or seepage had occurred except where structural or shrinkage cracks were evident. Figures 11 and 12 illustrate typical poured-in-place slabs which have given maintenance-free service on structures at the Naval Communication Station, Finegayan. The dark appearance of the roof on the house shown in Figure 12 resulted from a biological growth which is common to warm and humid areas.

FIGURE 11. EXPOSED POUR-IN-PLACE CON-
CRETE DECK, BOQ, NCS, FINEGAYEN, AGE:
3 YEARS.

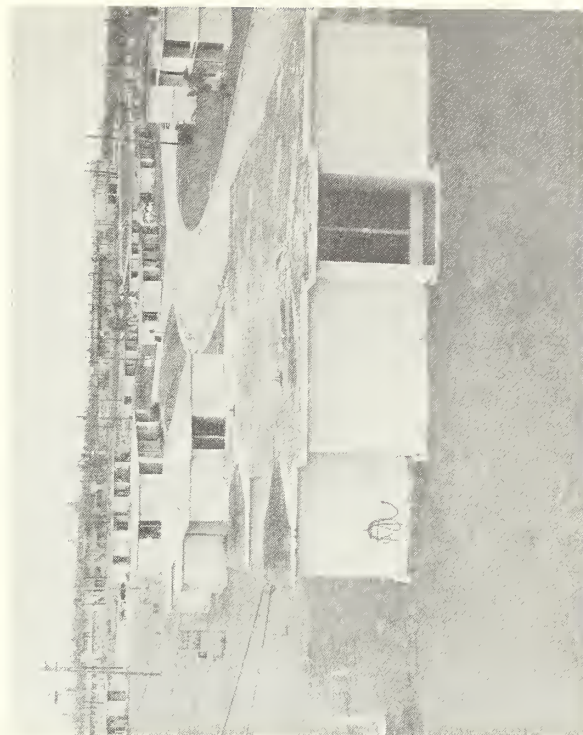
FIGURE 12. POUR-IN-PLACE CONCRETE
DECK. AGE: 10 YEARS.

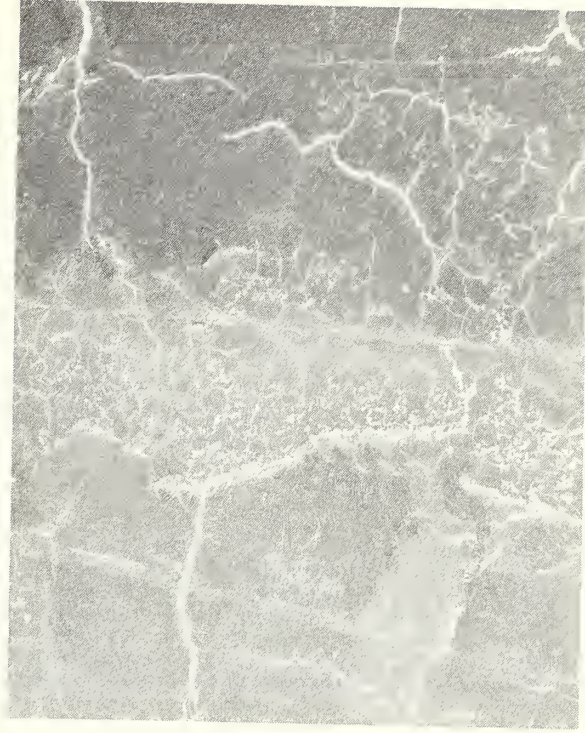
FIGURE 16. SURFACE DETERIORATION OF
BUILT-UP ROOFING AFTER 2 YEARS
EXPOSURE.

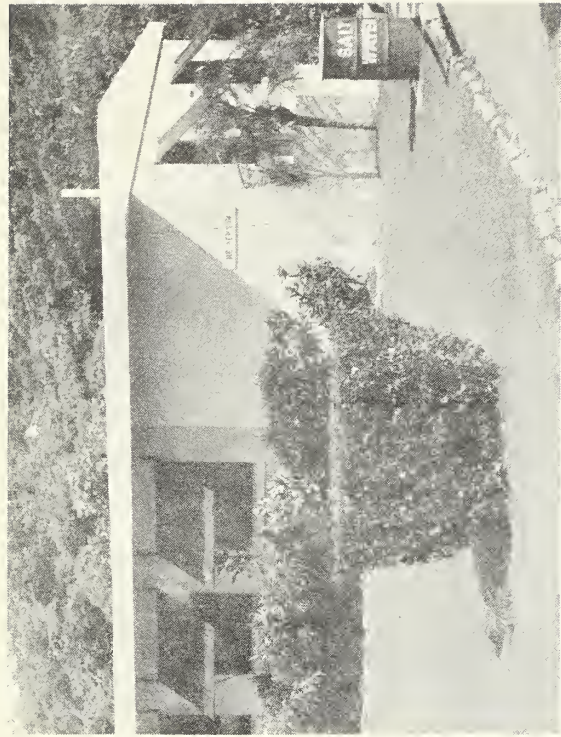
FIGURE 22. TYPICAL HOUSE, SUKIRAN AREA.

The performance of the glass mat - asphalt emulsion, etc., roofing system appeared to be quite satisfactory on both sloping and flat roofs. Figure 22 illustrates a typical home protected with such a roof and Figure 23 shows the roofing after about 11 years exposure. This system required periodic recoatings with the aluminum compound.

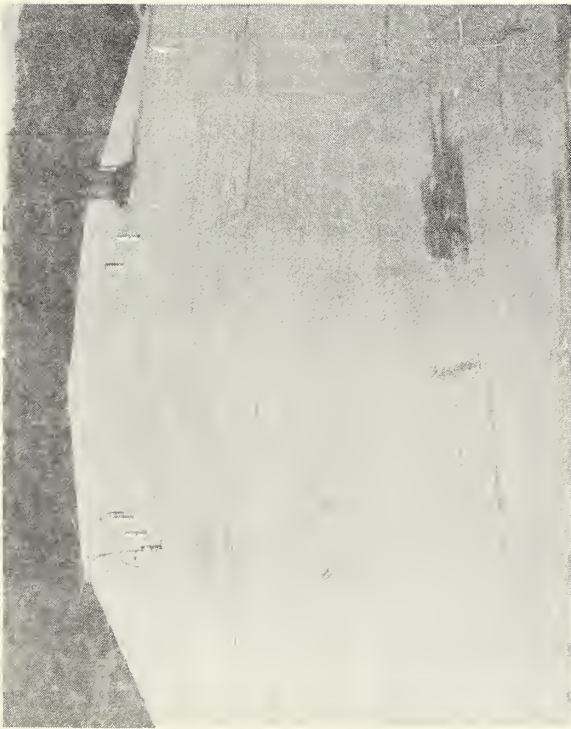
believe that it did not substantially contribute to premature failures. Examples of this defect were observed at Fort Buckner as illustrated in Figure 19 after 9 years exposure and on the built-up roof of the prototype barracks building (Figure 20) located at Camp Butler as evidenced by the numerous repaired areas shown in Figure 21.

FIGURE 21. ALUMINUM-SURFACED BUILT-UP ROOFING APPLIED 1957.

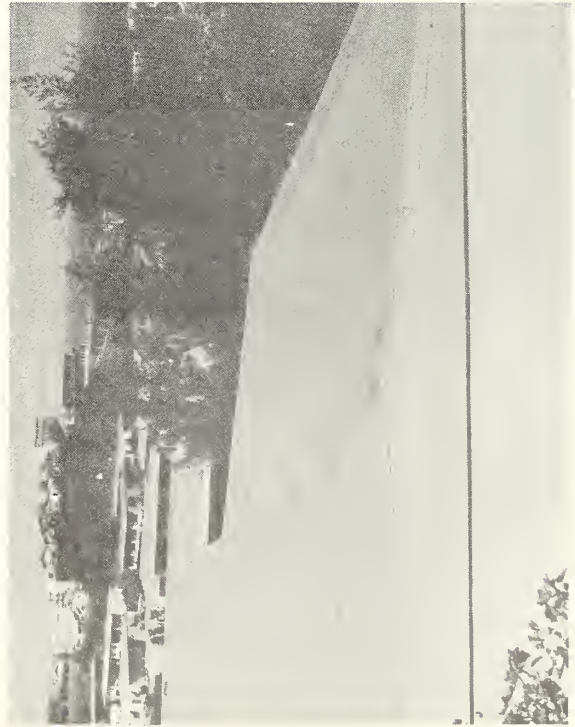
FIGURE 23. ASPHALT EMULSION-GLASS FABRIC ROOFING AFTER 11 YEARS EXPOSURE.

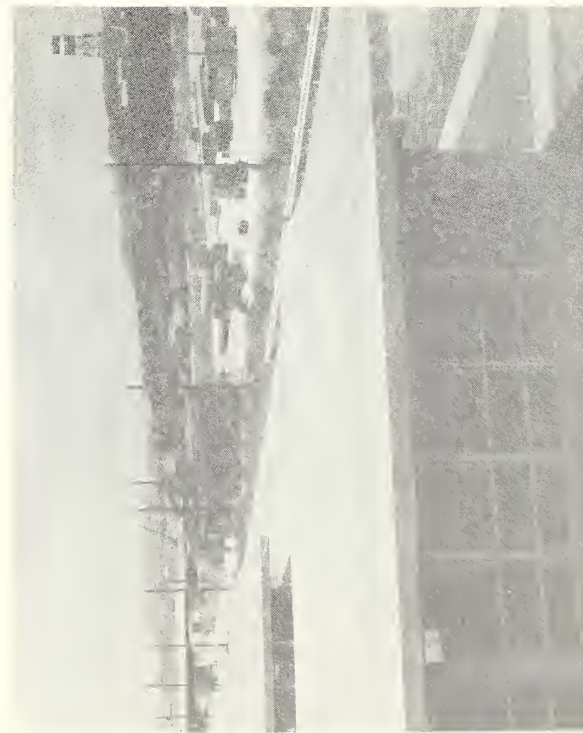
FIGURE 27. TREATMENT OF INTER-PANEL JOINTS ON PRECAST DECK, CAMP HANSEN.
